Construction-technical survey of a historical building in Locket

Aleš Kaňkovský, Martin Dědič, Institute of Technology and Business in České Budějovice, Department of Civil Engineering, 370 01 České Budějovice, Czech Republic

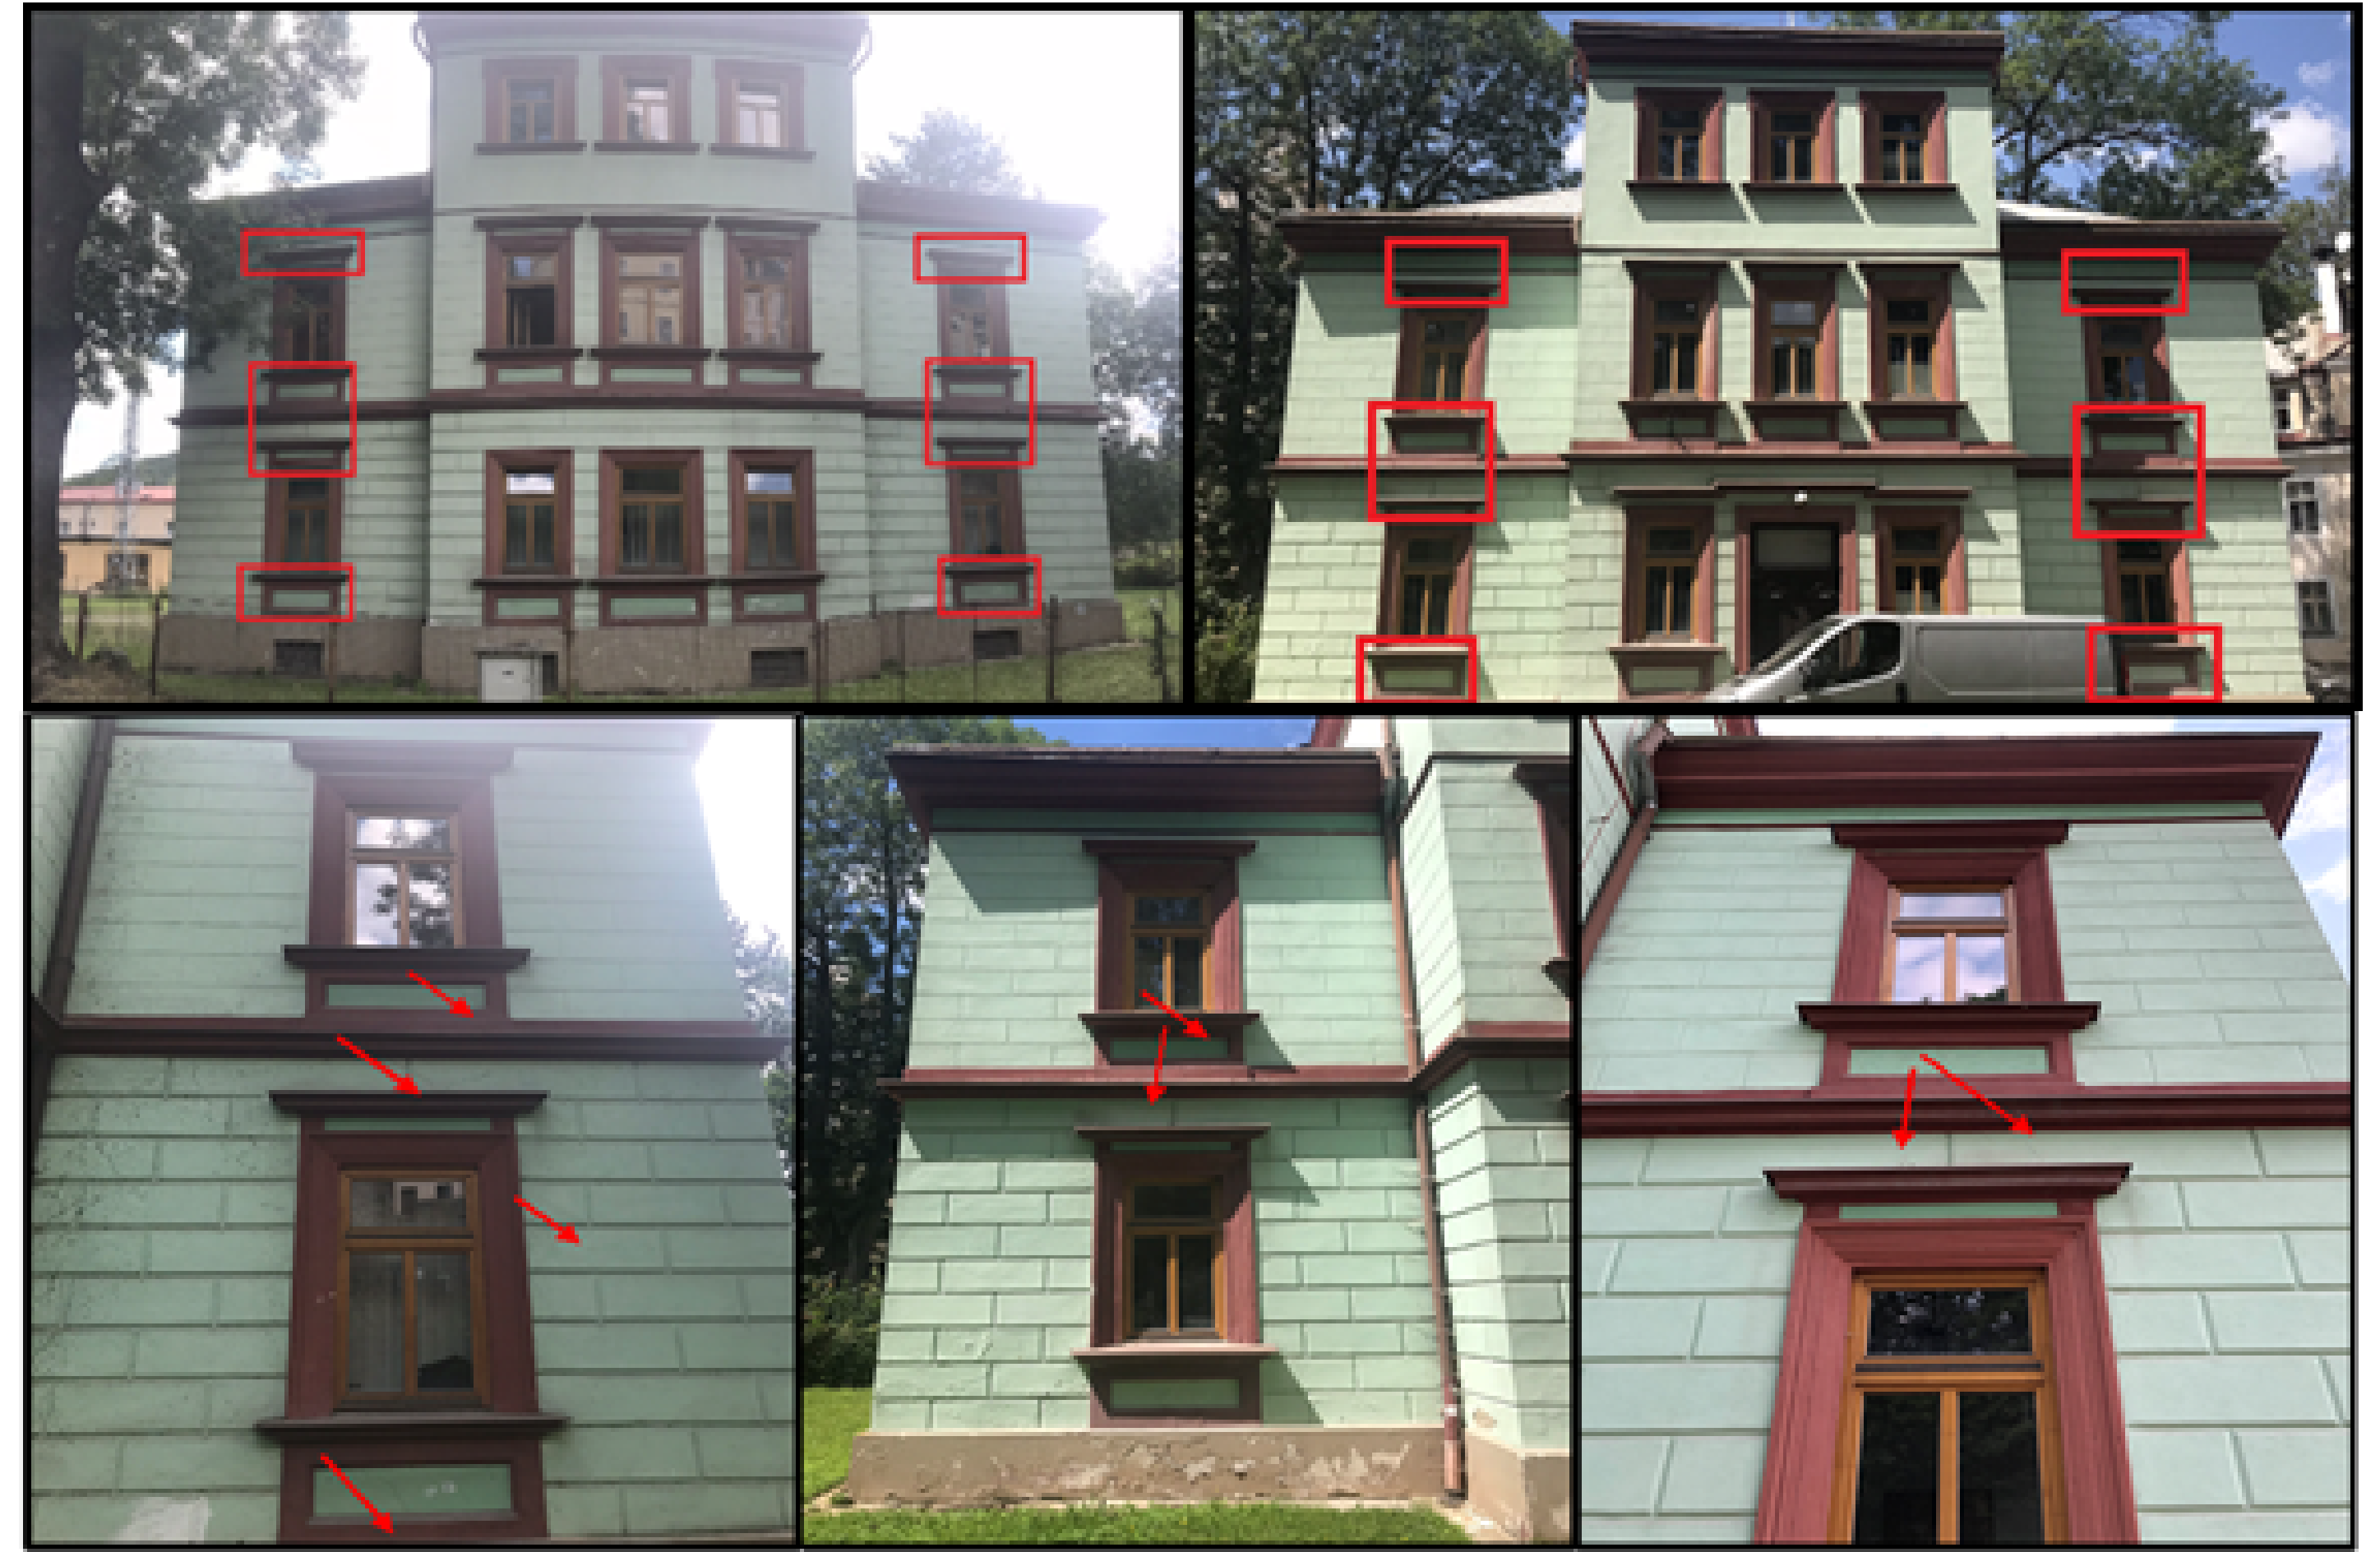
Cracks in the joints of the perimeter masonry in the area around the window openings (lintel, lining, window sill) at both extreme parts of the building can be caused by two possible causes.

a) The building foundation

The first possibility is a change in the soil conditions in the basement of the building, caused by the mentioned floods in 2009. As these are old cracks in the vertical and horizontal joints of the masonry, these cracks indicate a gradual decline of the structure (foundation), see figure below.

b) Structure overload

The second possibility, due to cracks in the place of the window lintel, is the overload of the lintel by the wooden ceiling, or the ceiling beam placed in the place above the window lintel. Due to the fact that the building has changed the purpose of use many times in the past (housing, civic amenities), there were changes in the values of the live load, while increasing these live load values could lead to the overloading of the ceiling structure. Due to the subsequent distribution of forces, it decreased in the weakened place of the lintel, which caused cracks in the brick vault, which were reflected in the plaster at the junction of the lintel and the window lining. With a slight decrease in the window lintel, the ceiling structure in the place where the beam was placed probably also decreased, which also caused a decrease in the window sill above the ceiling structure due to the occurrence of deformations.

The western and eastern facades of the building with the marked places and direction of the cracks.

- Carry out humidity measurements of the affected wall and ceiling structures in the cellars.
- In the place of cracks on the facade of the building, perform a complete removal of the plaster inside the building, in the affected places around the window openings, and finding out the actual extent of damage by static load cracks.

- Carry out crack measurements using a plaster target.
- Carry out a diagnosis of wooden elements in the truss, find out the actual extent of damage to elements exposed to moisture / wood-destroying insects, fungi, and rot.

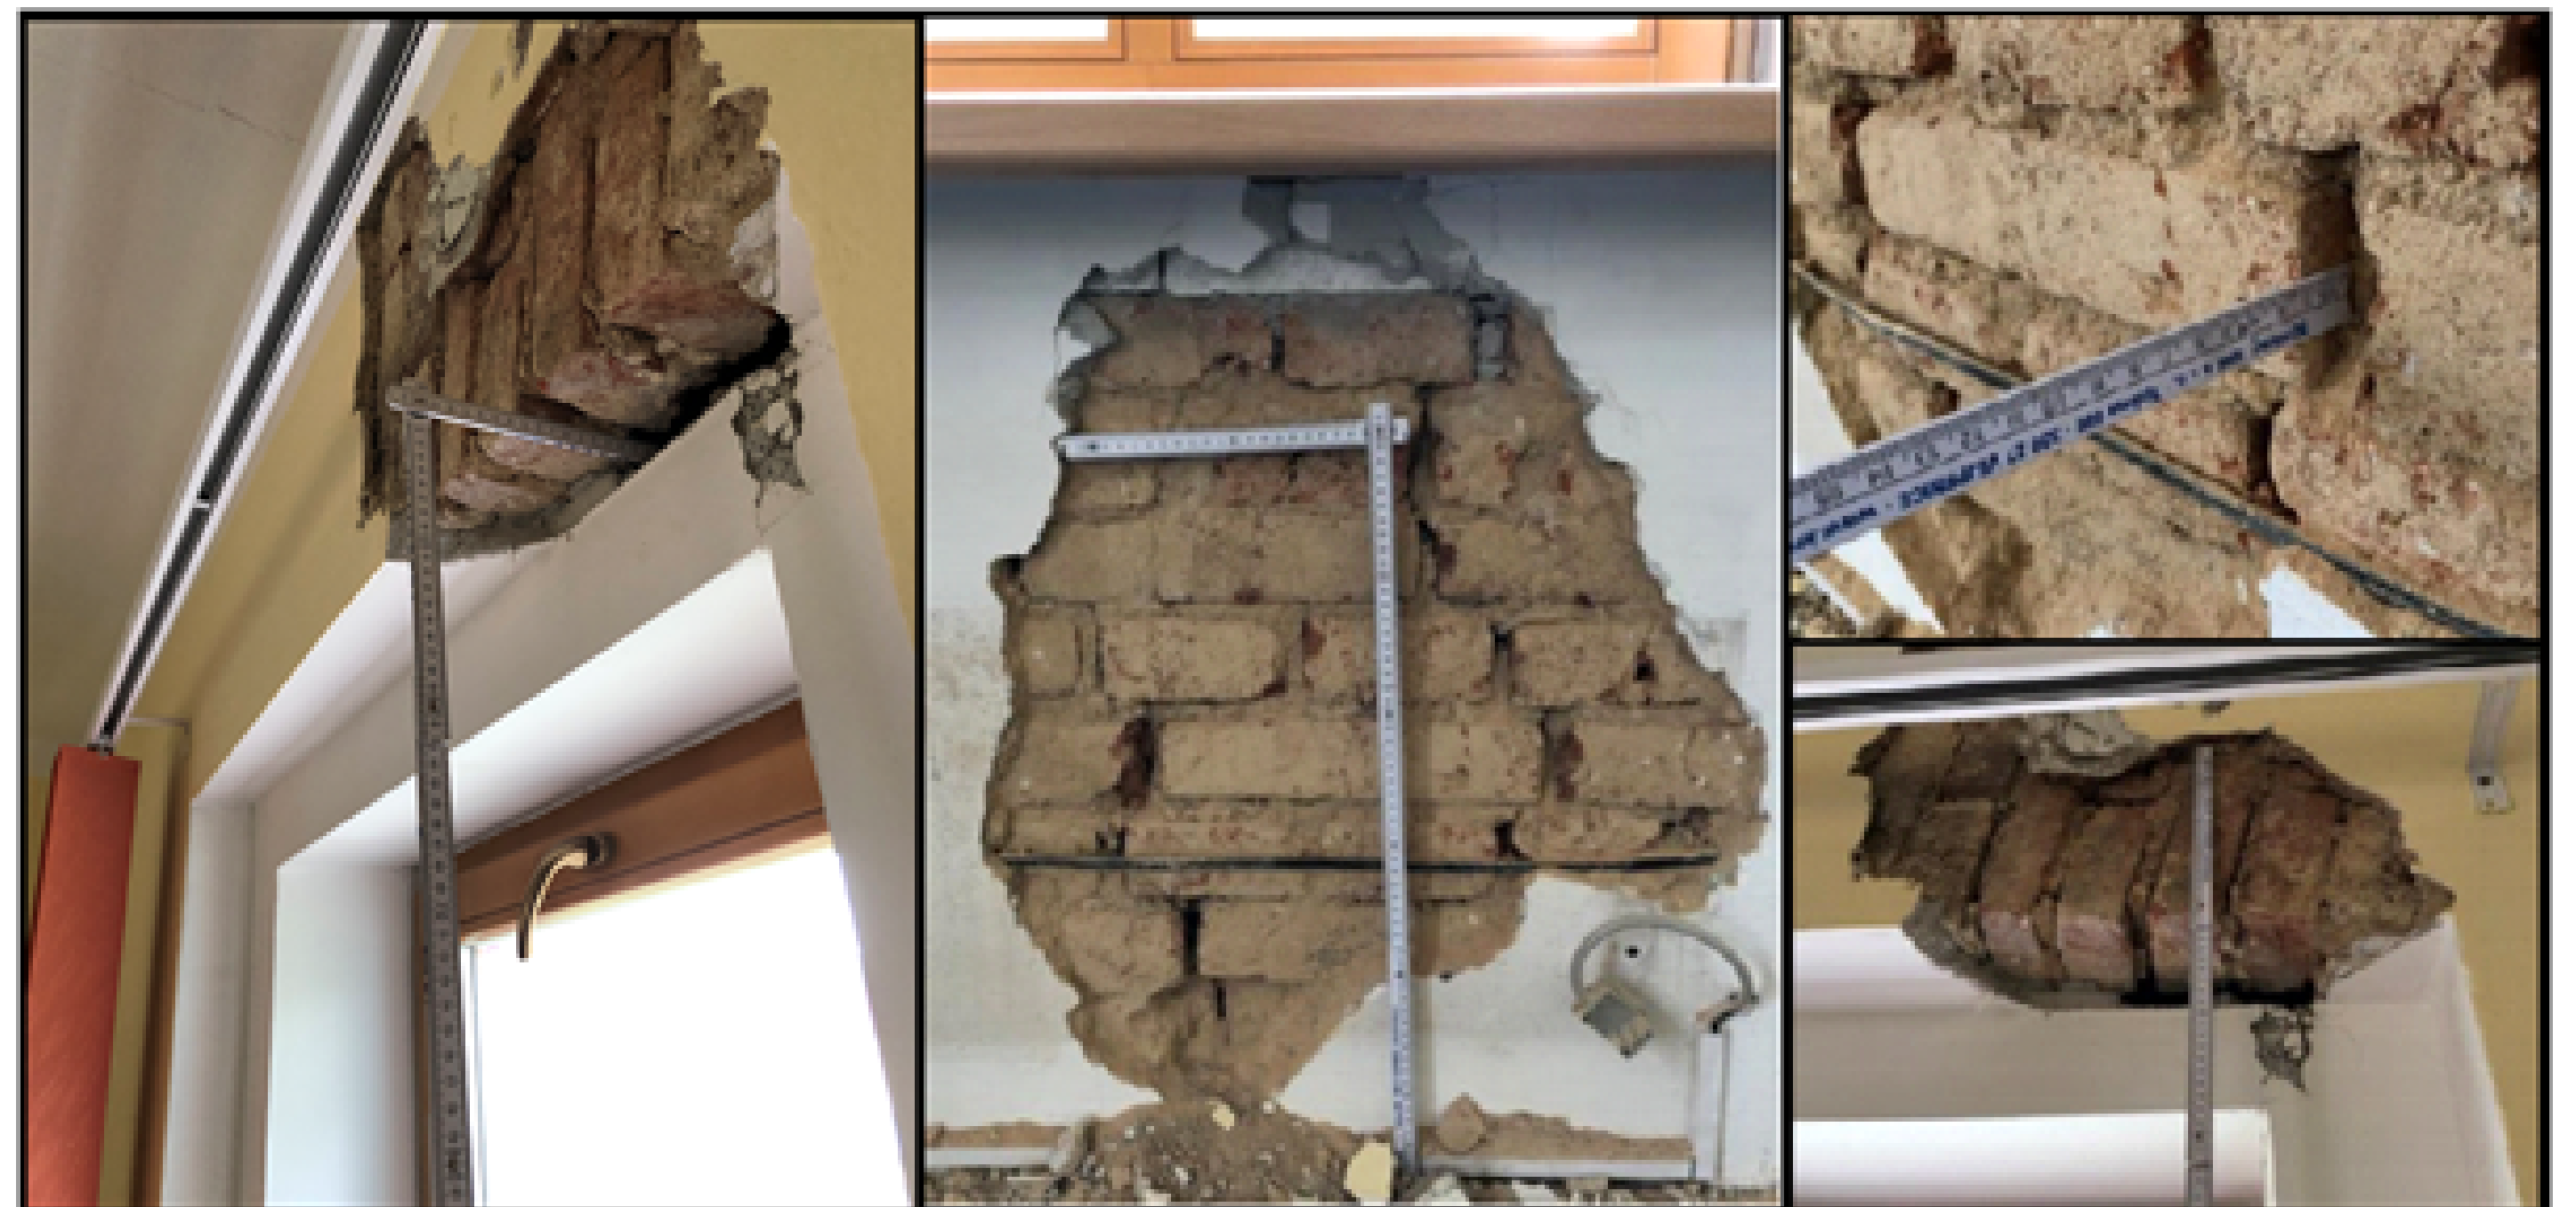
The probe in the window sill and lintel on the 2nd floor of the building east wing.

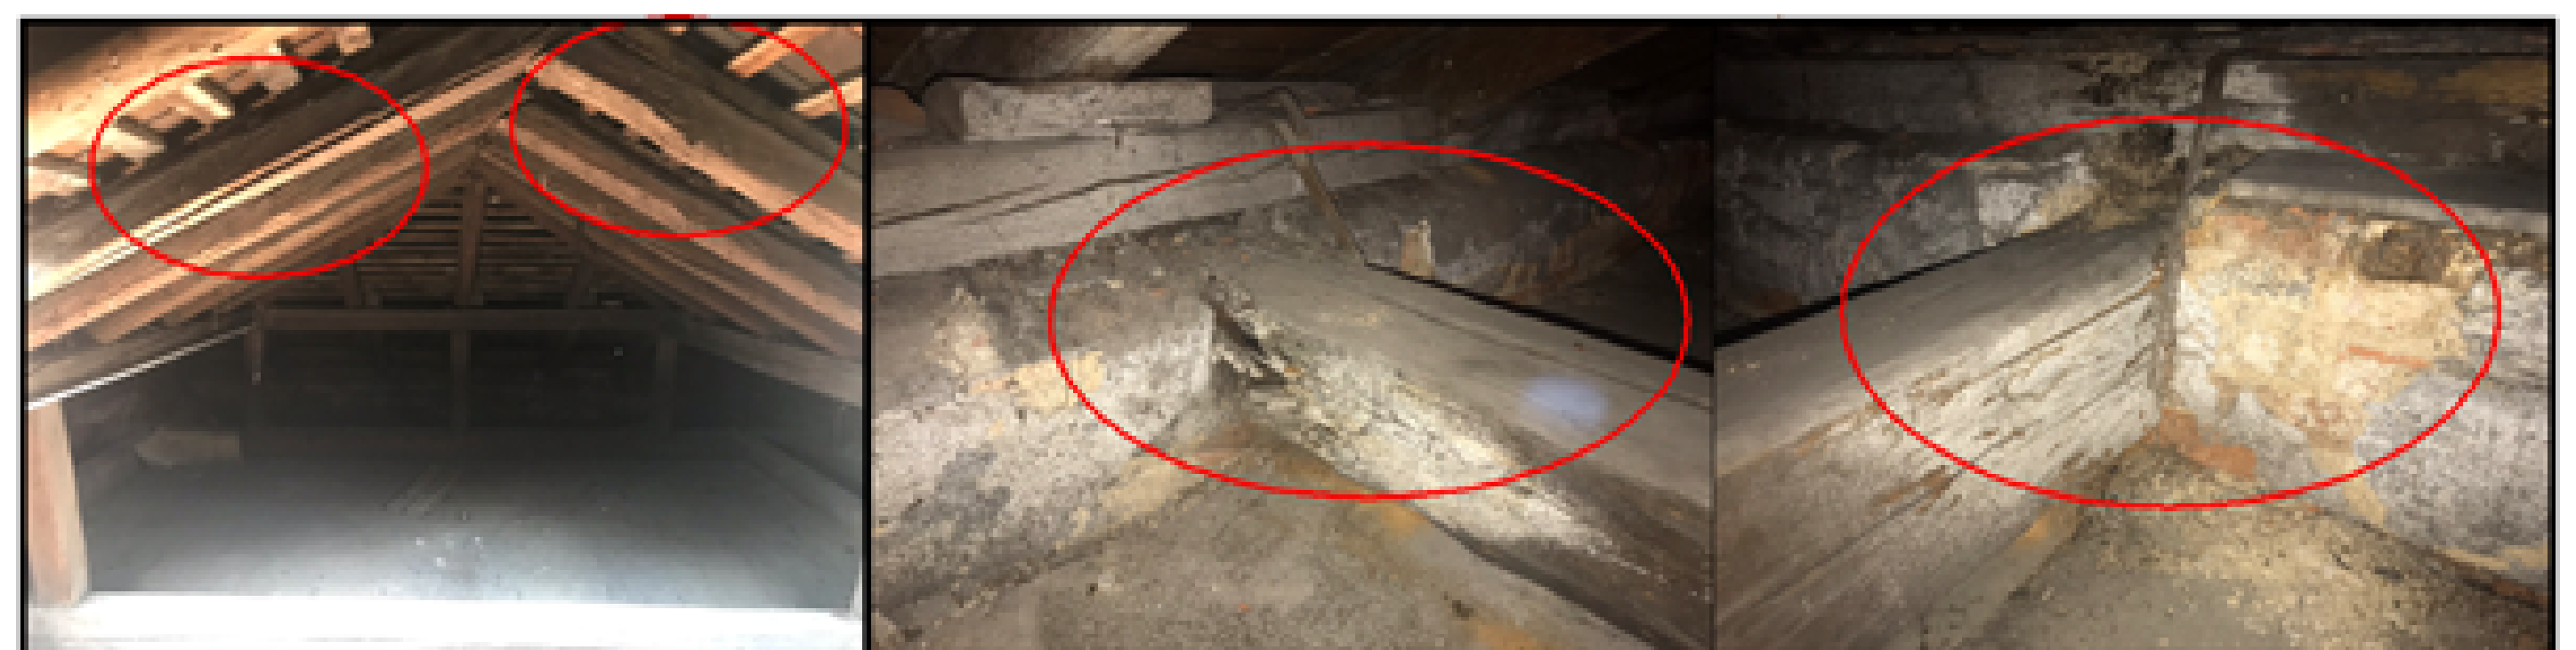
In the past, the roof most likely underwent a partial reconstruction, during which the roof covering (currently profiled sheet metal) was replaced and a waterproofing under-roof layer - foil - was additionally used in the truss of the building south wing. The attacked wooden truss elements are located in the parts of the north wing and the central part, without the hydro insulating foil. For this reason, the cause of the disintegration of the tops of wooden tie beams is mainly moisture in the structure due to leakage into it, which in long-term action, together with suitable temperature conditions and truss maintenance, causes wood-destroying rot, wood-destroying fungi and wood-destroying insects. As some wooden elements have deep surface scratches of a specific form, these may be ingestions caused by beetles "*Corymbia Rubra*" or "*Lyctus brunneus*".

The extent of wooden truss elements damage
